PCB ABATEMENT CLOSEOUT SUMMARY REPORT

**SKY VALLEY EDUCATION CENTER
351 Short Columbia Street
Monroe, Washington**

October 2016
PBS Project # 41373.000

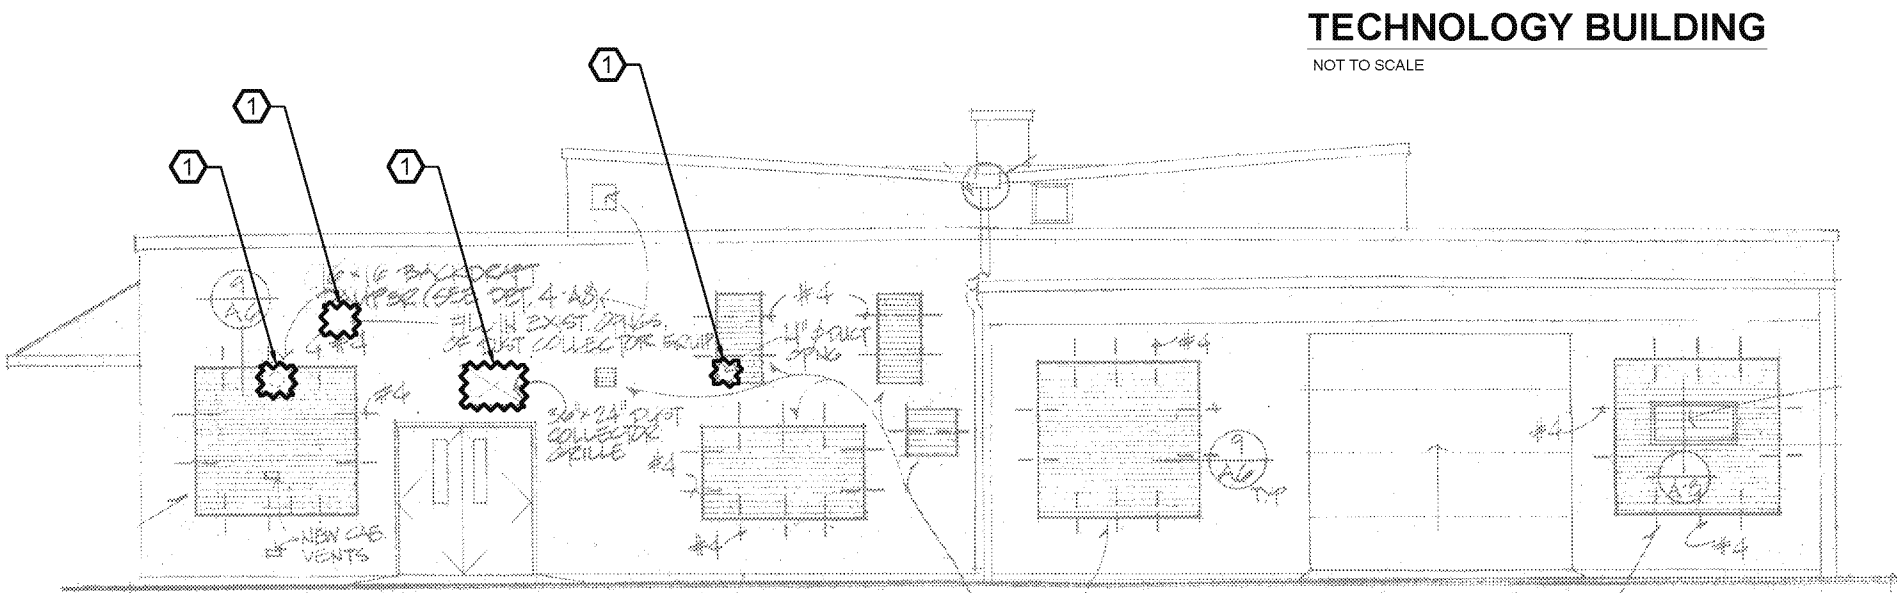
1 TECHNOLOGY BUILDING EAST
HM5 NOT TO SCALE

- 1 REMOVE APPROX. 60 LF OF PCB-CONTAINING CAULKING LOCATED ON EXTERIOR LOUVERS, VENTS AND DUCTING ON METAL TRANSITIONS ON THE WEST AND EAST EXTERIOR ELEVATIONS OF THE TECHNOLOGY BUILDING AS SHOWN.

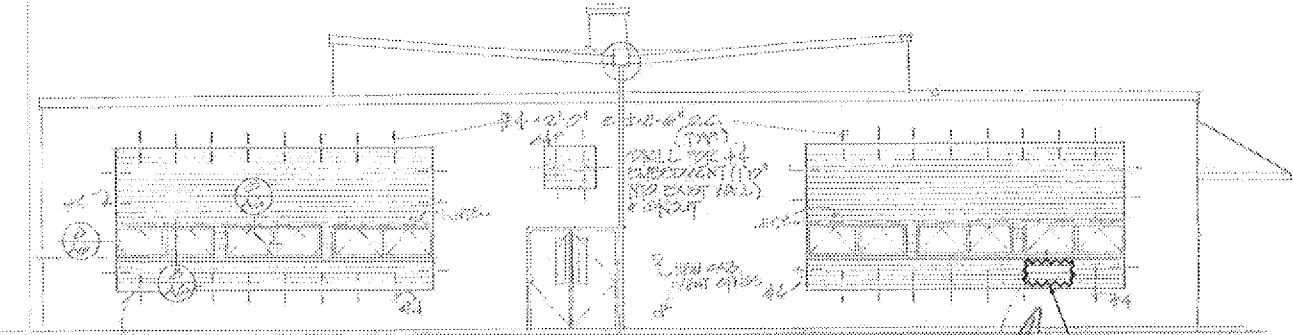
2 TECHNOLOGY BUILDING WEST
HMS NOT TO SCALE

- KEY NOTES**
1. REMOVE APPROX. 60 LF OF PCB-CONTAINING CAULKING LOCATED ON EXTERIOR LOUVERS, VENTS AND DUCTING ON METAL TRANSITIONS ON THE WEST AND EAST EXTERIOR ELEVATIONS OF THE TECHNOLOGY BUILDING AS SHOWN.

10ft
8/30/16
3ft x 4 = 12ft
Total
